Slope Stability Assessment

Bridle Path North Arva Inc.

Proposed Residential Development
Medway Road and Richmond Street, Arva, Ontario

Geotechnical Report

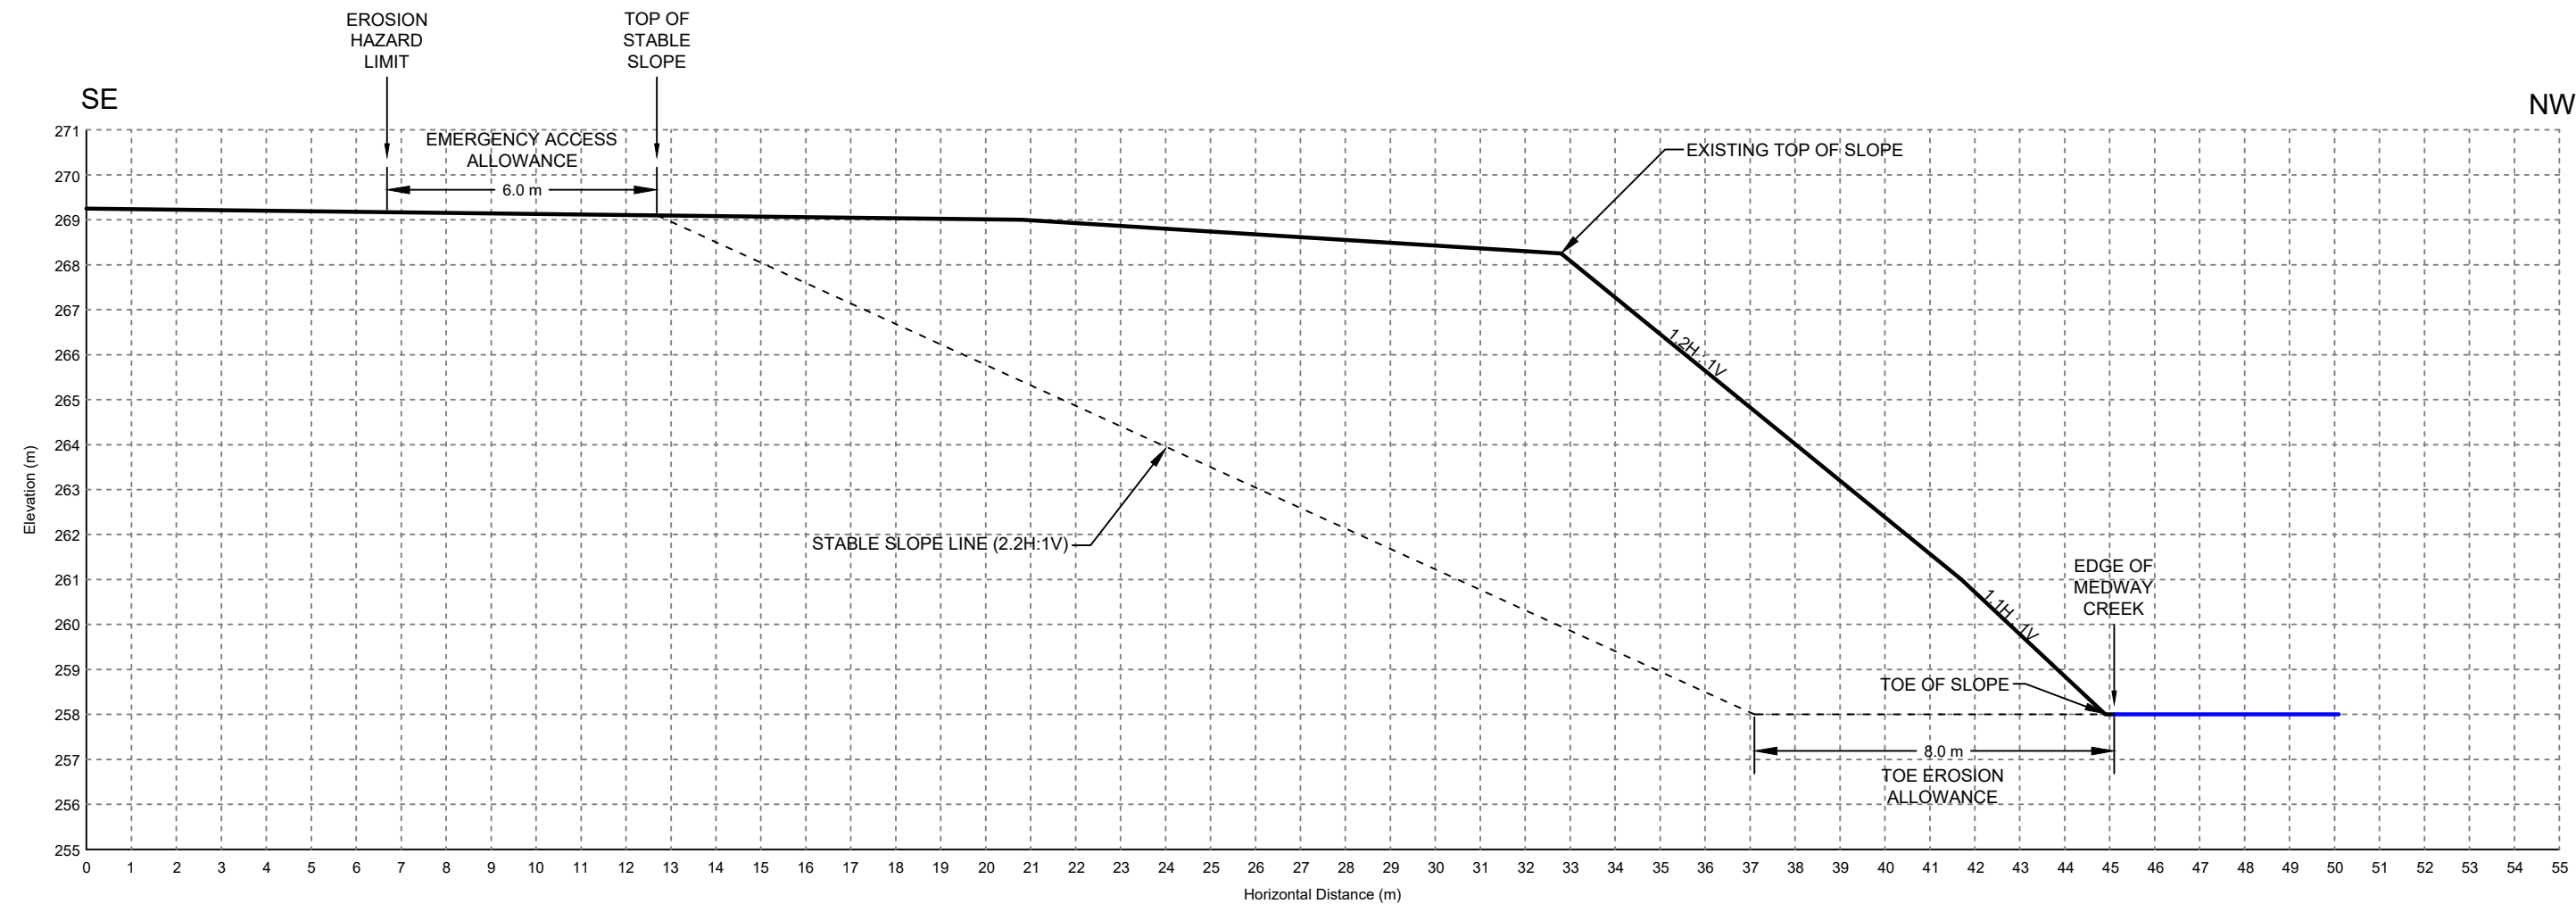
Cross Section A - A'

Cross Section Condition	Description of Failure Mode	Computer Factor of Safety
Cross Section A-A'	Shallow to Moderate Depth Failure	1.04
	Deep Failure	1.36
Cross Section C-C'	Shallow to Moderate Depth Failure	1.29
	Deep Failure	1.51
Cross Section D-D'	Shallow to Moderate Depth Failure	2.16
	Deep Failure	2.15
Cross Section G-G'	Shallow to Moderate Depth Failure	2.02
	Deep Failure	2.22
Cross Section A-A' (2.2H:1V)	Minimum Failure Mode	1.95

A stable slope inclination of 2.2H:1V was applied to the critical cross section based on the slope analyses carried out. To ensure that a satisfactory factor of safety (FOS) is applied for the Erosion Hazard Limit along the slopes at the Site, the stable slope setback line should be drawn from the toe erosion allowance, where applicable. The stable slope allowance of 2.2H:1V has been applied based on a conservative evaluation and to exceed the target FOS of 1.40.
