## Hydrogeological Assessment

### FINAL REPORT

Medway Creek – Bridle Path Subdivision  
Arva, Ontario

KCH-21002415-A0

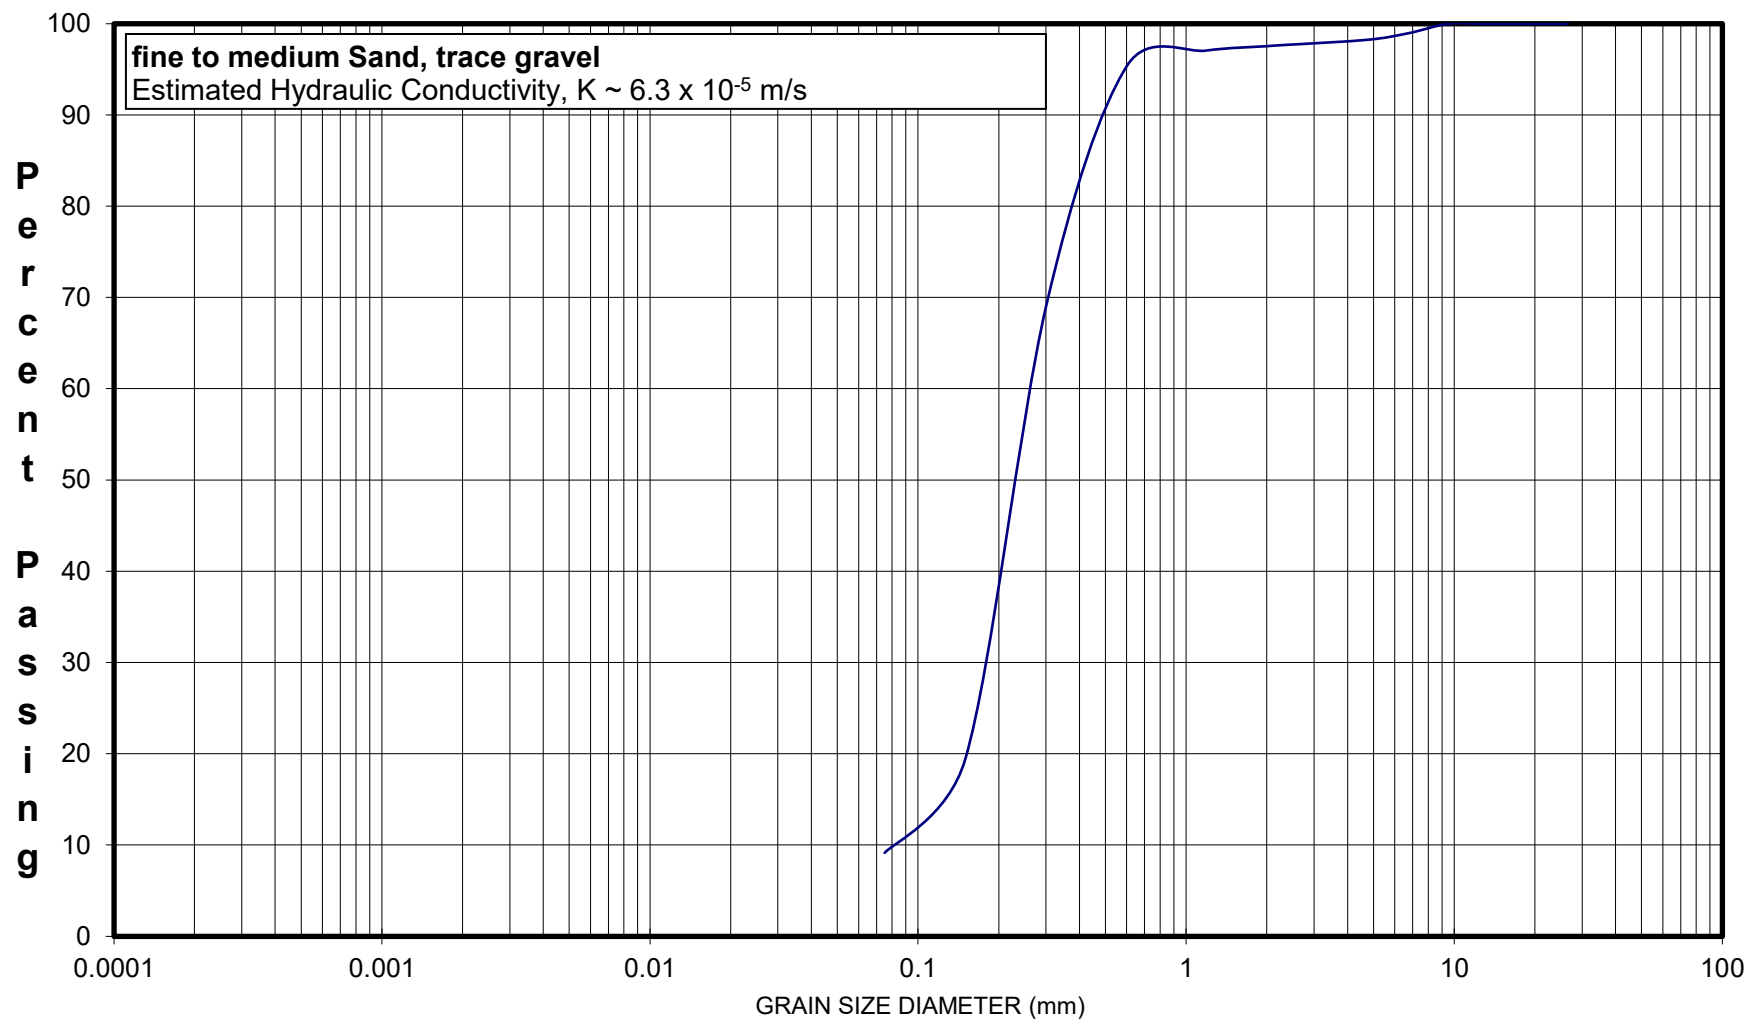
CLAY	FINE	MEDIUM	COARSE	FINE	MEDIUM	COARSE	FINE	MEDIUM	COARSE	
	SILT			SAND			GRAVEL			
MODIFIED M.I.T. CLASSIFICATION		Sample Description: fine to medium SAND (BH 1 SA 5)				Arva Medway Creek Development Project: LON-21002415-A0			Figure 1

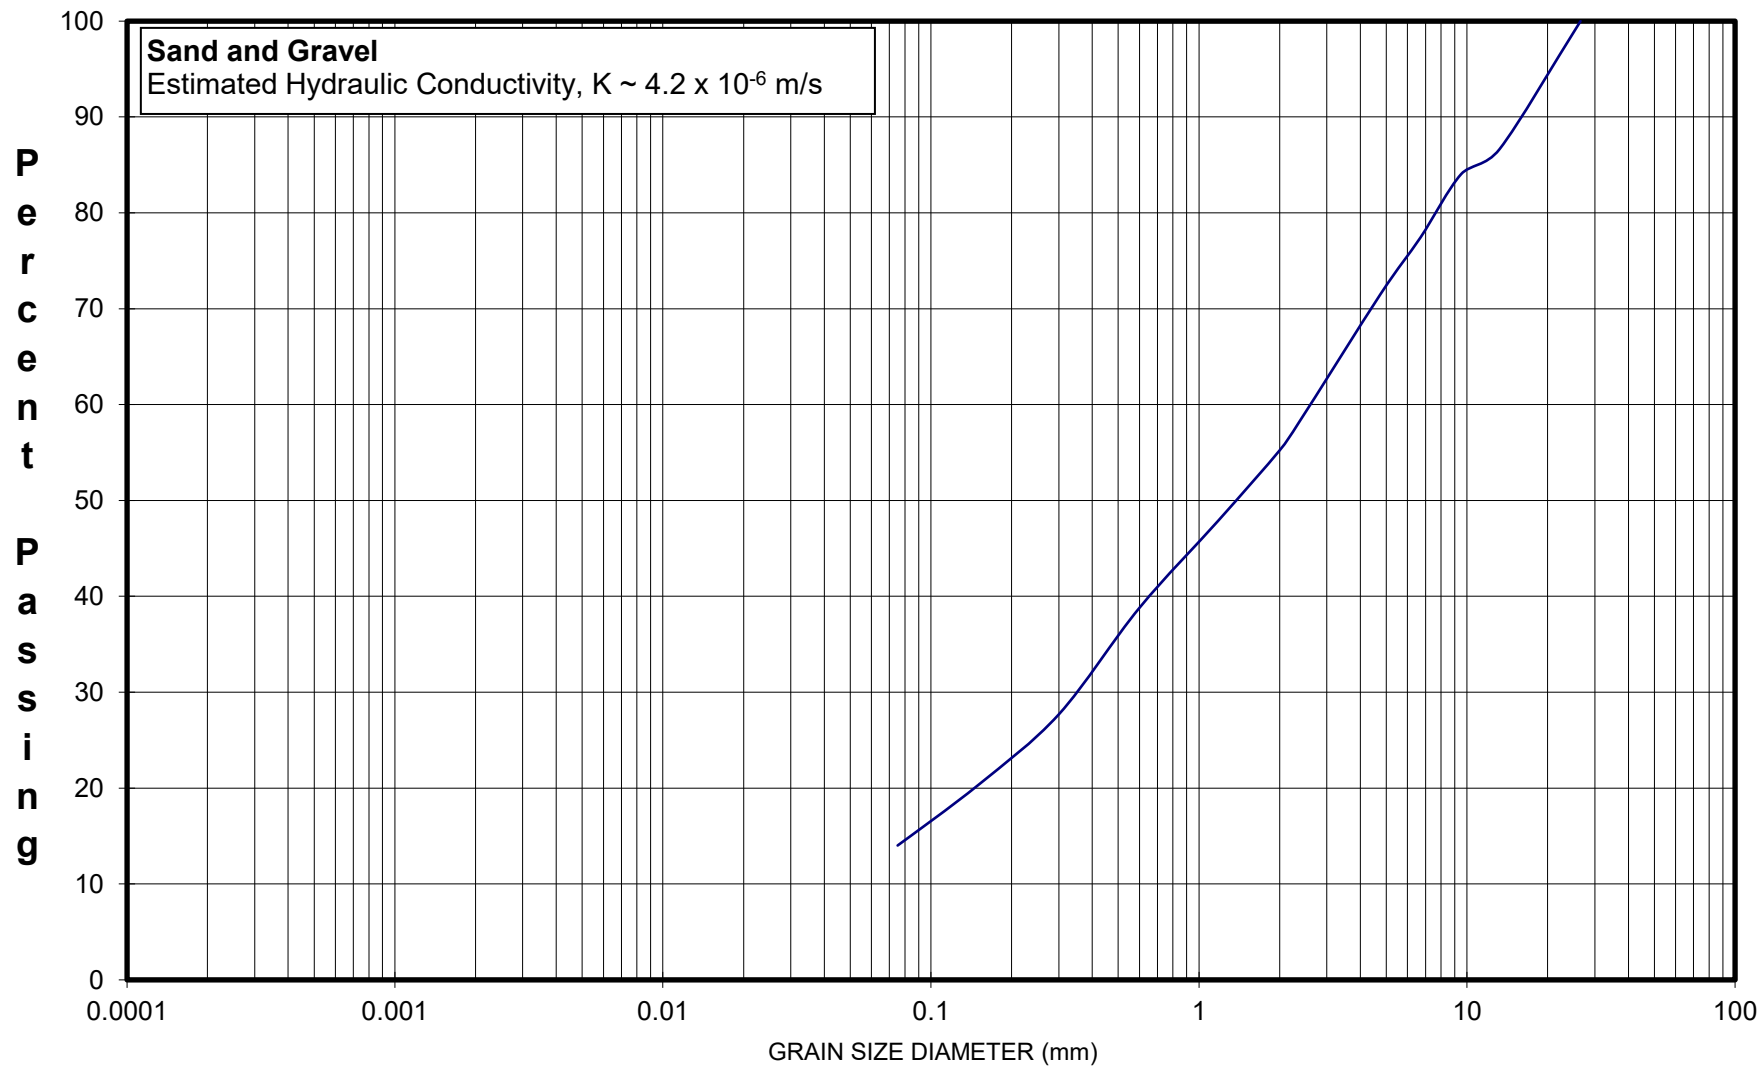
CLAY	FINE	MEDIUM	COARSE	FINE	MEDIUM	COARSE	FINE	MEDIUM	COARSE	
	SILT			SAND			GRAVEL			
MODIFIED M.I.T. CLASSIFICATION		Sample Description: Sand and Gravel (BH 2 SA 2)				Arva Medway Creek Development Project: LON-21002415-A0			Figure 2

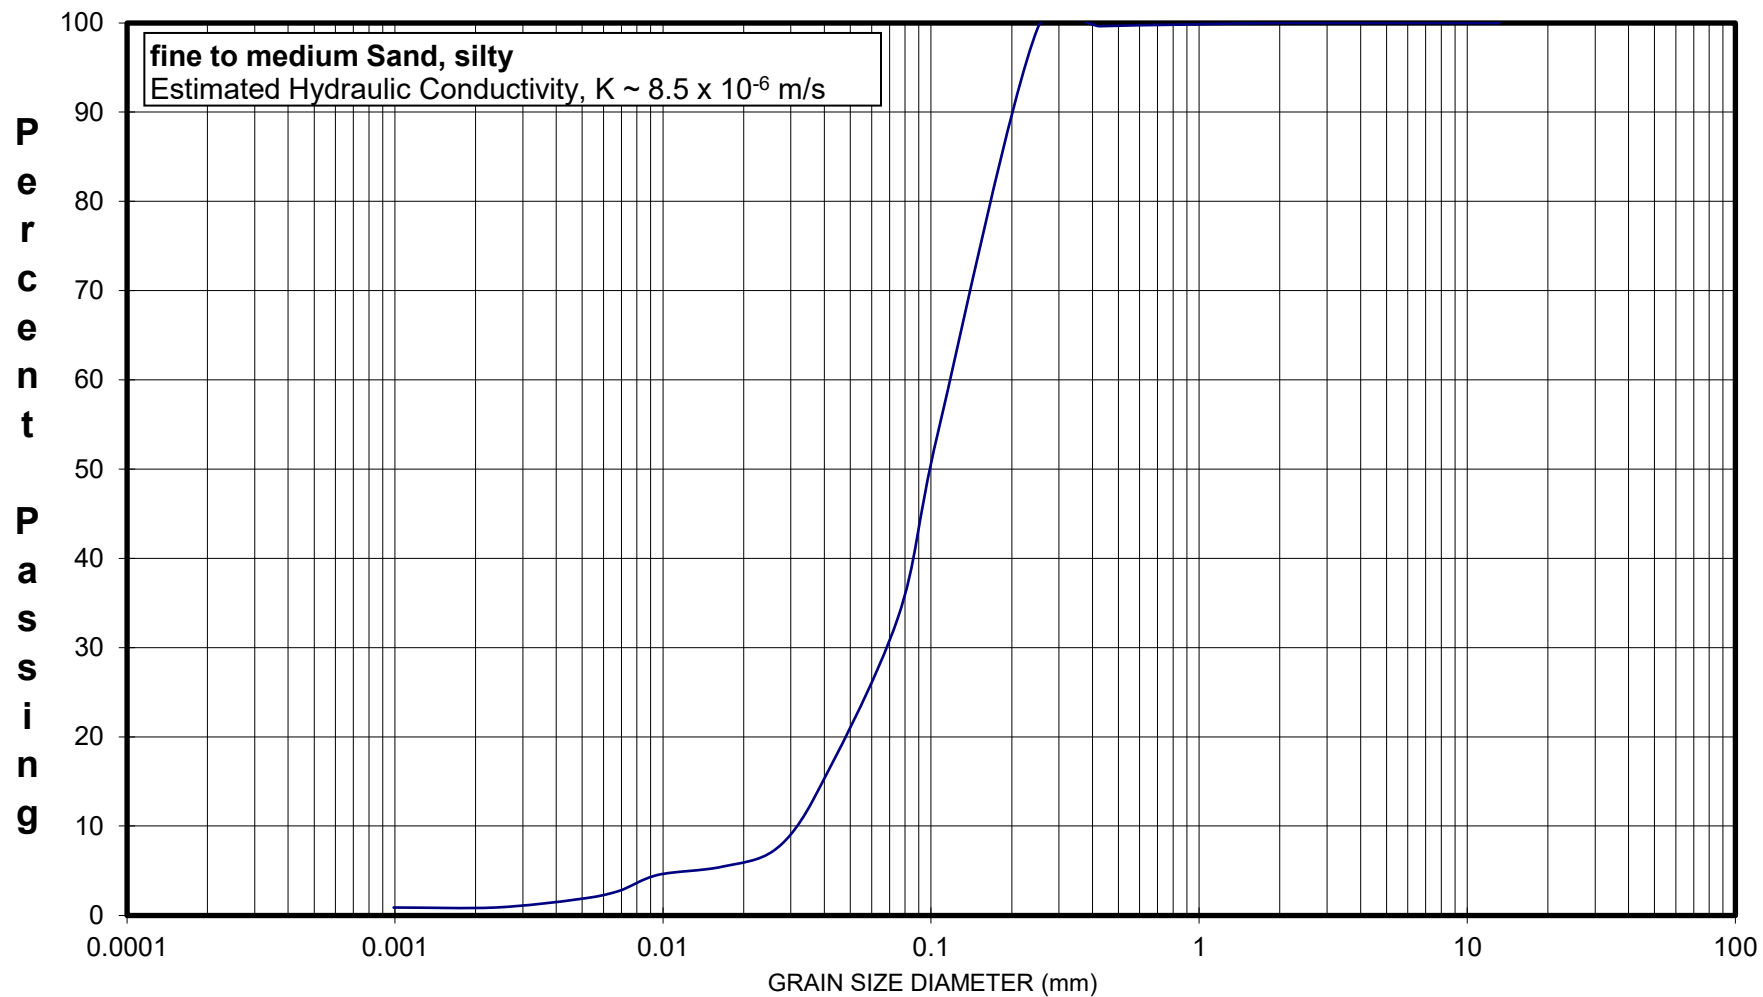
CLAY	FINE	MEDIUM	COARSE	FINE	MEDIUM	COARSE	FINE	MEDIUM	COARSE	
	SILT			SAND			GRAVEL			
MODIFIED M.I.T. CLASSIFICATION		Sample Description: fine to medium Sand (BH 7 SA 4)				Arva Medway Creek Development			Figure 3

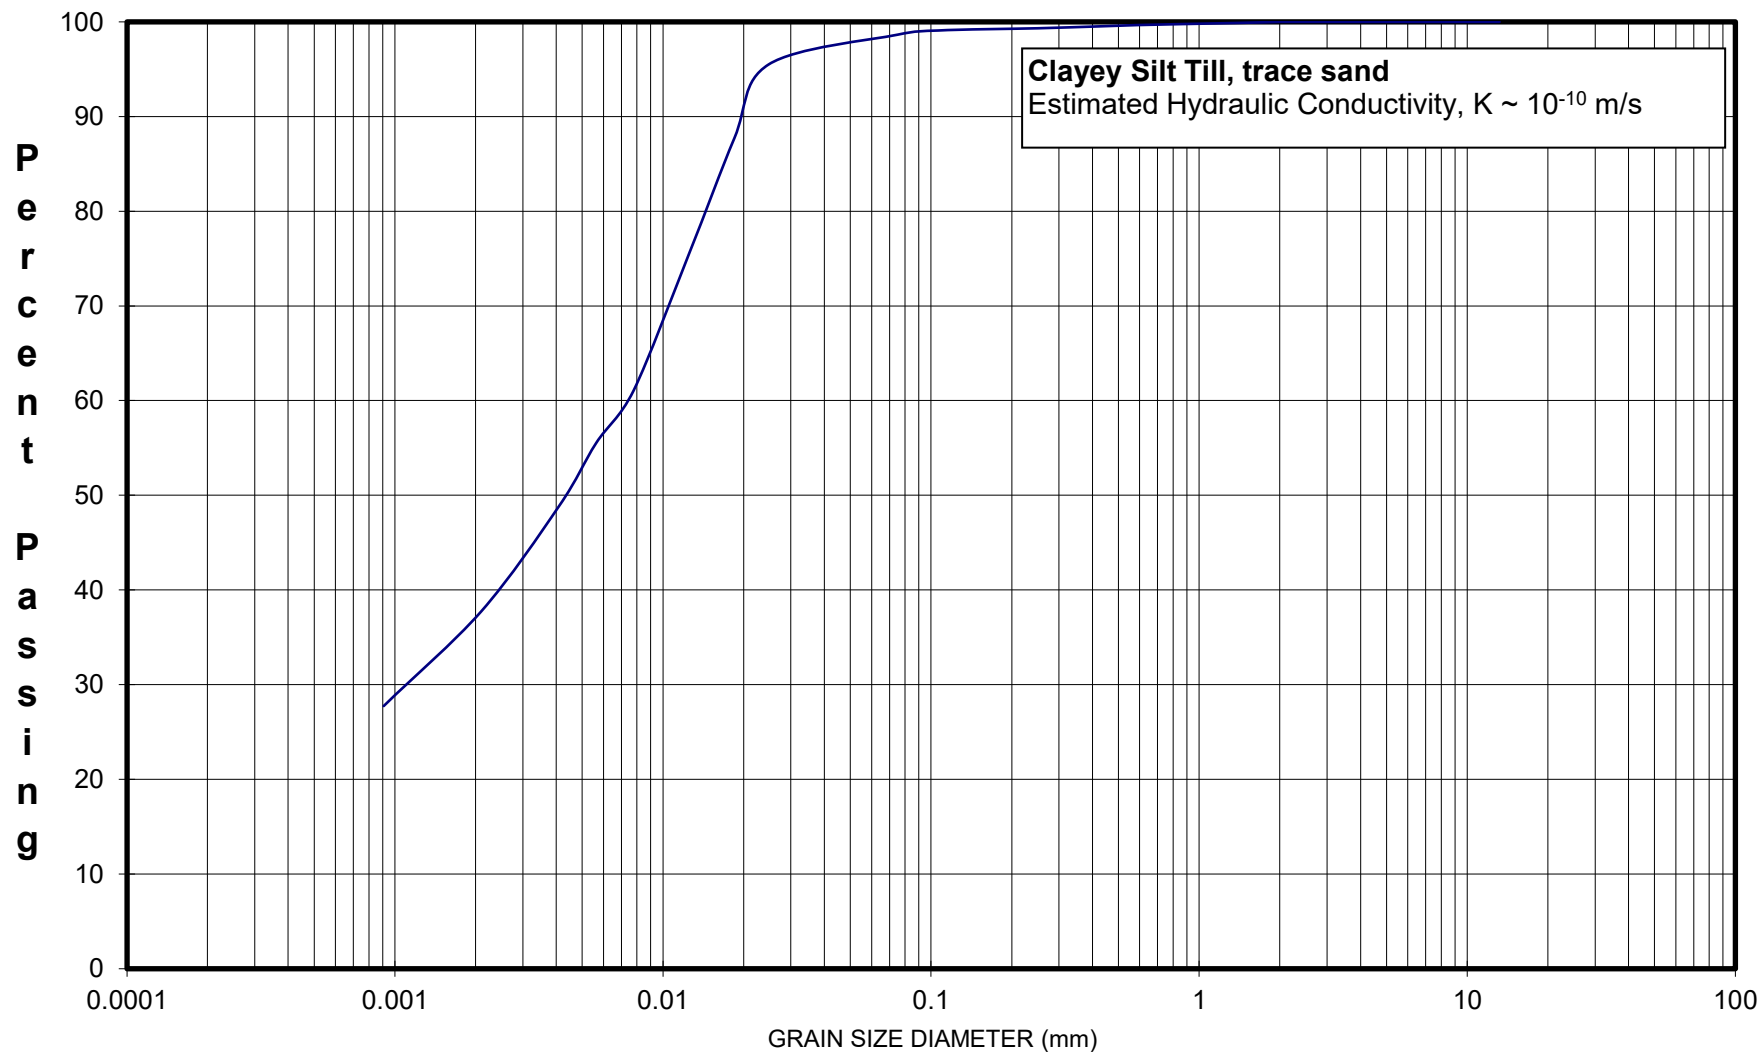
CLAY	FINE	MEDIUM	COARSE	FINE	MEDIUM	COARSE	FINE	MEDIUM	COARSE	
	SILT			SAND			GRAVEL			
MODIFIED M.I.T. CLASSIFICATION		Sample Description: Clayey Silt Till (BH 8 SA5)				Arva Medway Creek Development Project: LON-21002415-A0			Figure 5
