**ARVA SUBDIVISION
MEDWAY CREEK MEANDER BELT
ASSESSMENT**

Project Number:
161414396

Medway Creek Meander Belt Assessment

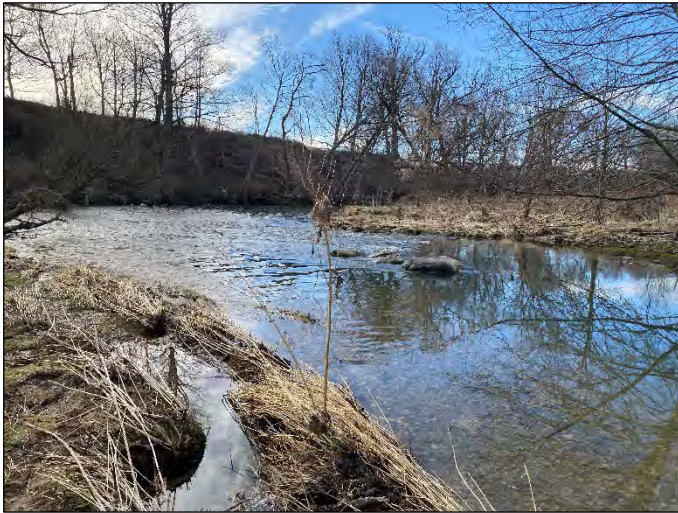
Photo 1: Reach 1, looking 150 m downstream of Highway 4

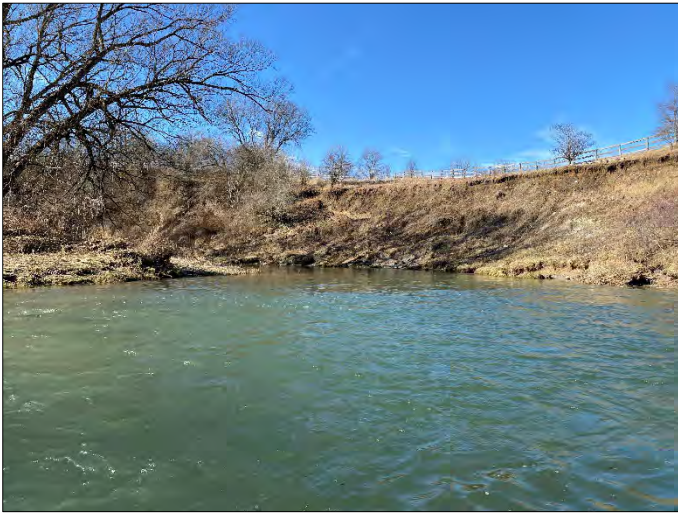
Photo 2: Outside bank confined by valley wall at Reach 1.

In a confined watercourse, channel migration is constrained by the valley wall. In the Study Area, the channel is partially confined, with sections located along the toe of the valley and the valley wall providing a constraint to channel migration. Where channel migration is constrained by the valley wall, the meander belt was delineated along the top of valley (TRCA, 2004). Therefore, in these areas, the erosion hazard limit will be governed by the stable top of slope assessment (by others; EXP 2023). The locations where this stable top of slope assessment will govern are indicated in Figure 1

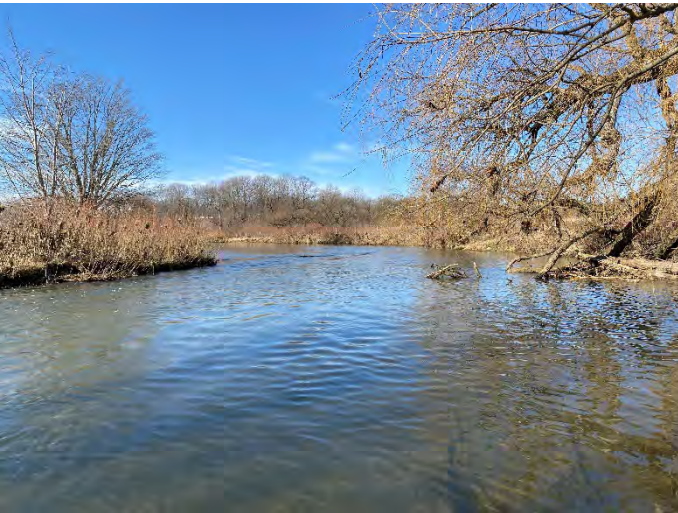
Photo 3: Reach 1 looking downstream, surrounded by shrub-sapling.

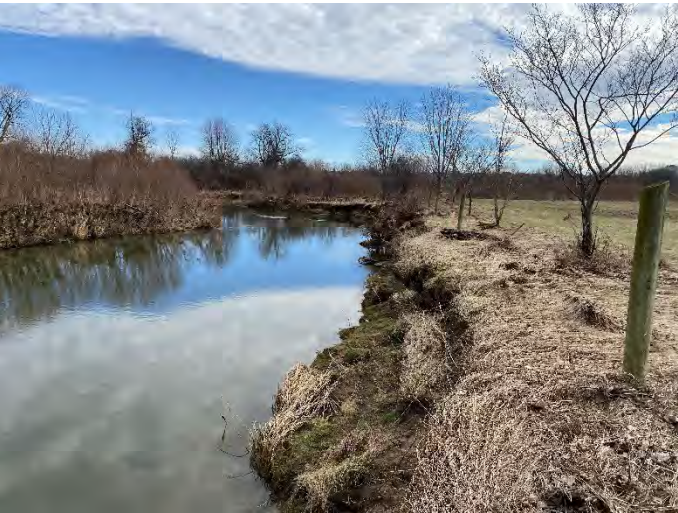
Photo 4: Upstream boundary of Reach 2, looking downstream.

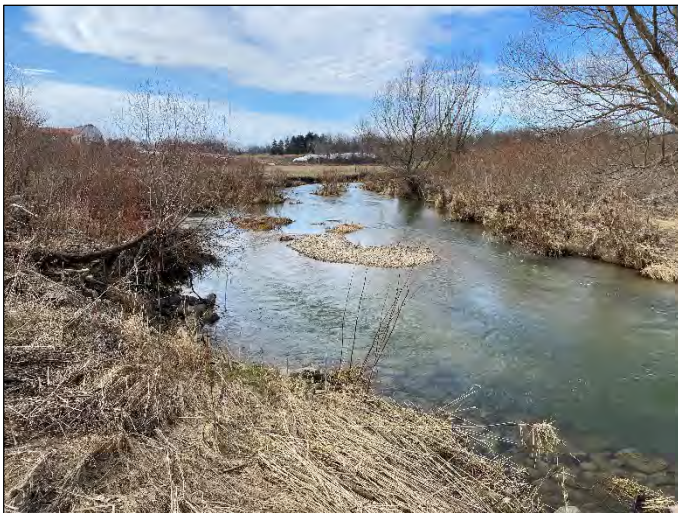
Photo 5: Bar formation, looking downstream of Reach 2.

Reach 2 was observed to have poorly formed pool-riffle bed morphology. Similar to Reach 1, instability and adjustment were observed throughout the reach, as evident by medial bar formation, poor sorting of bed materials, and bank erosion. Pasture was observed right up to the creek bank (i.e. lack of riparian vegetation) along several sections of the reach, which is likely contributing to the observed instability.

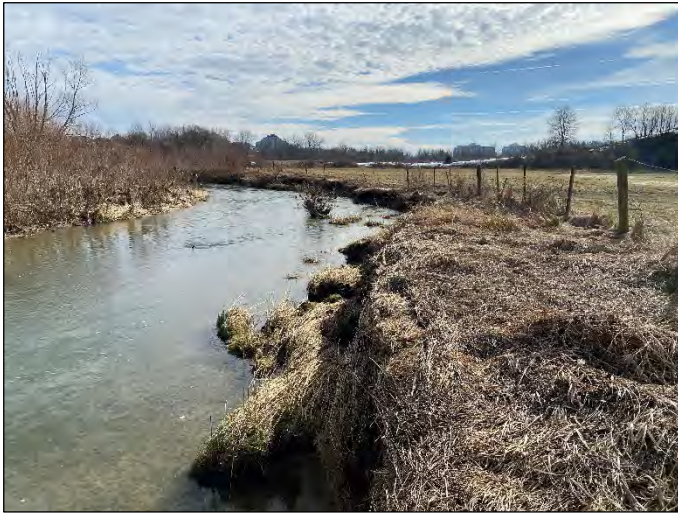
Photo 6: Looking downstream of Reach 2, bank observed to be migrating to farm field

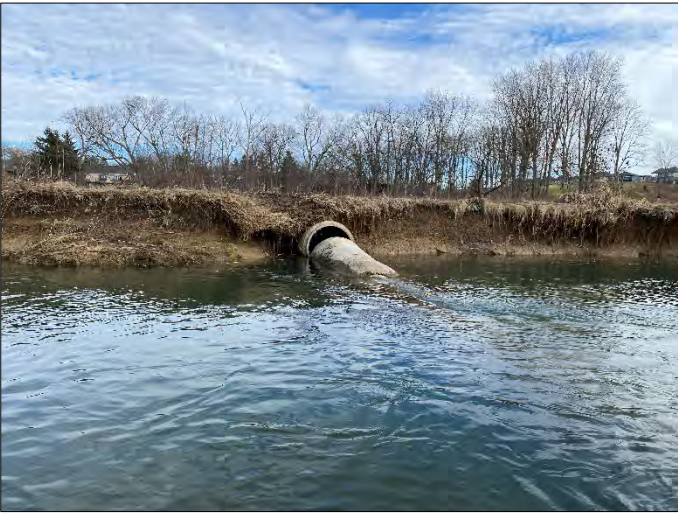
Photo 7: Culvert observed, downstream boundary of Reach 2.

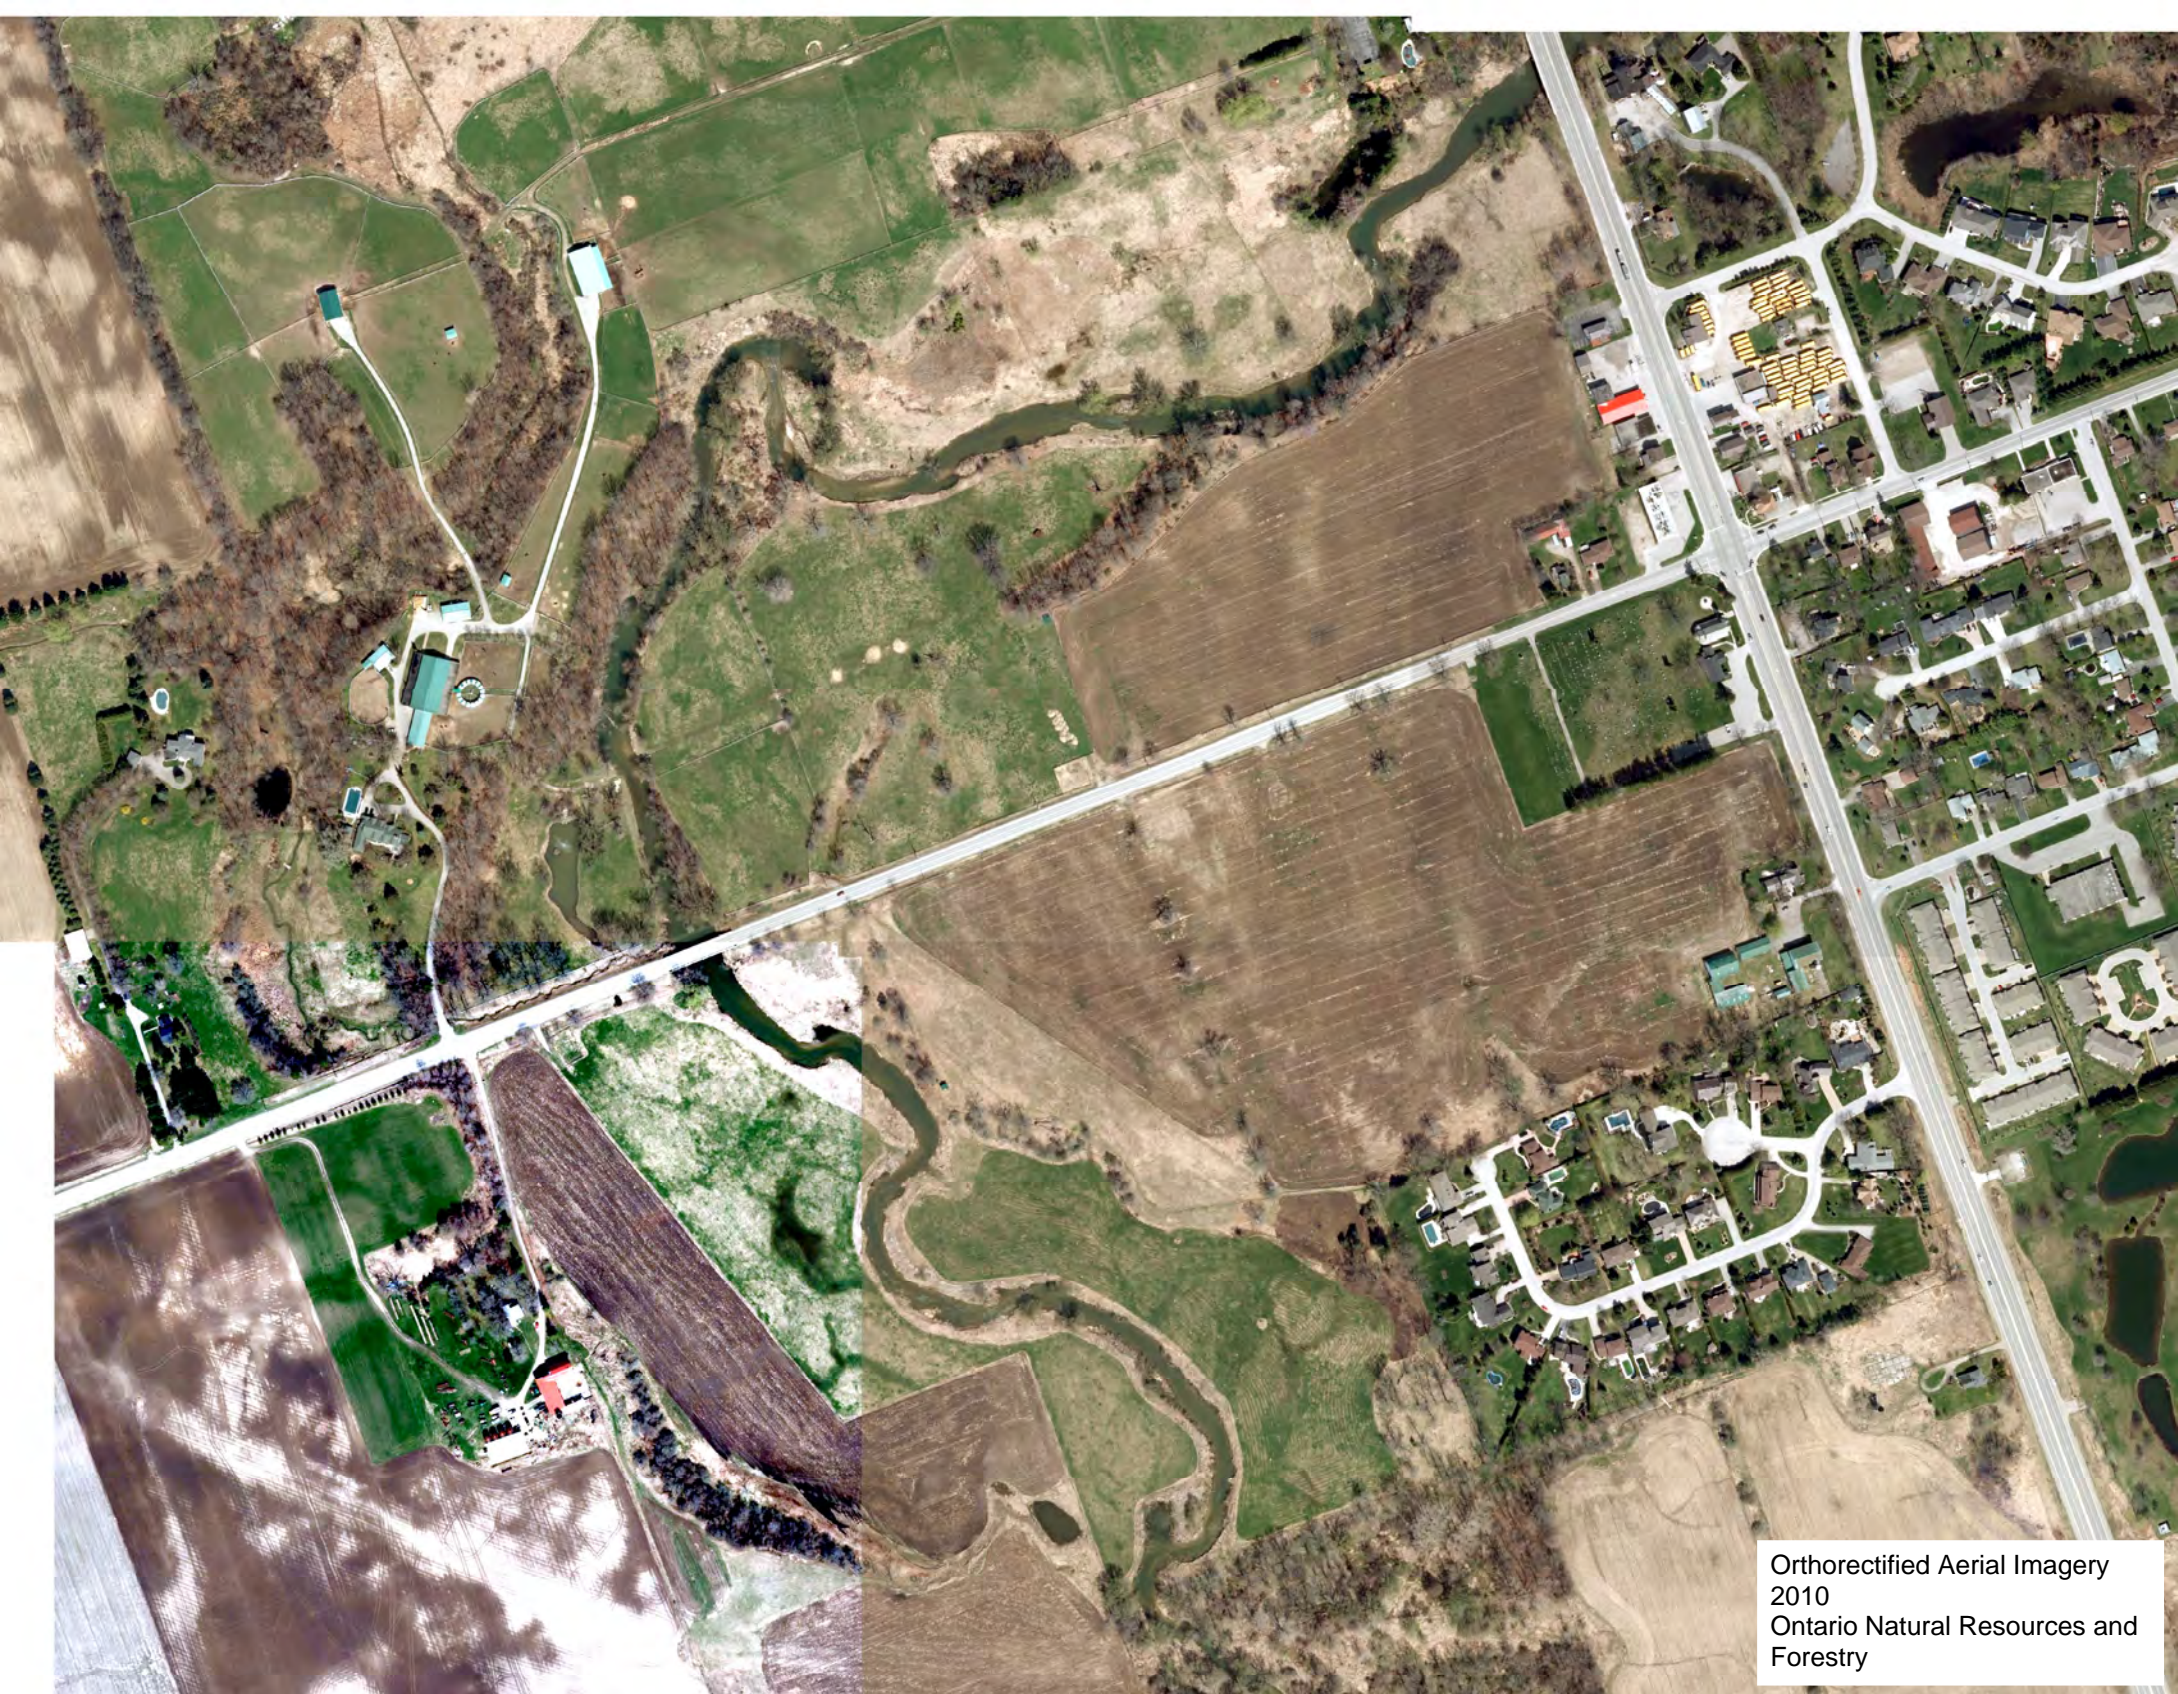
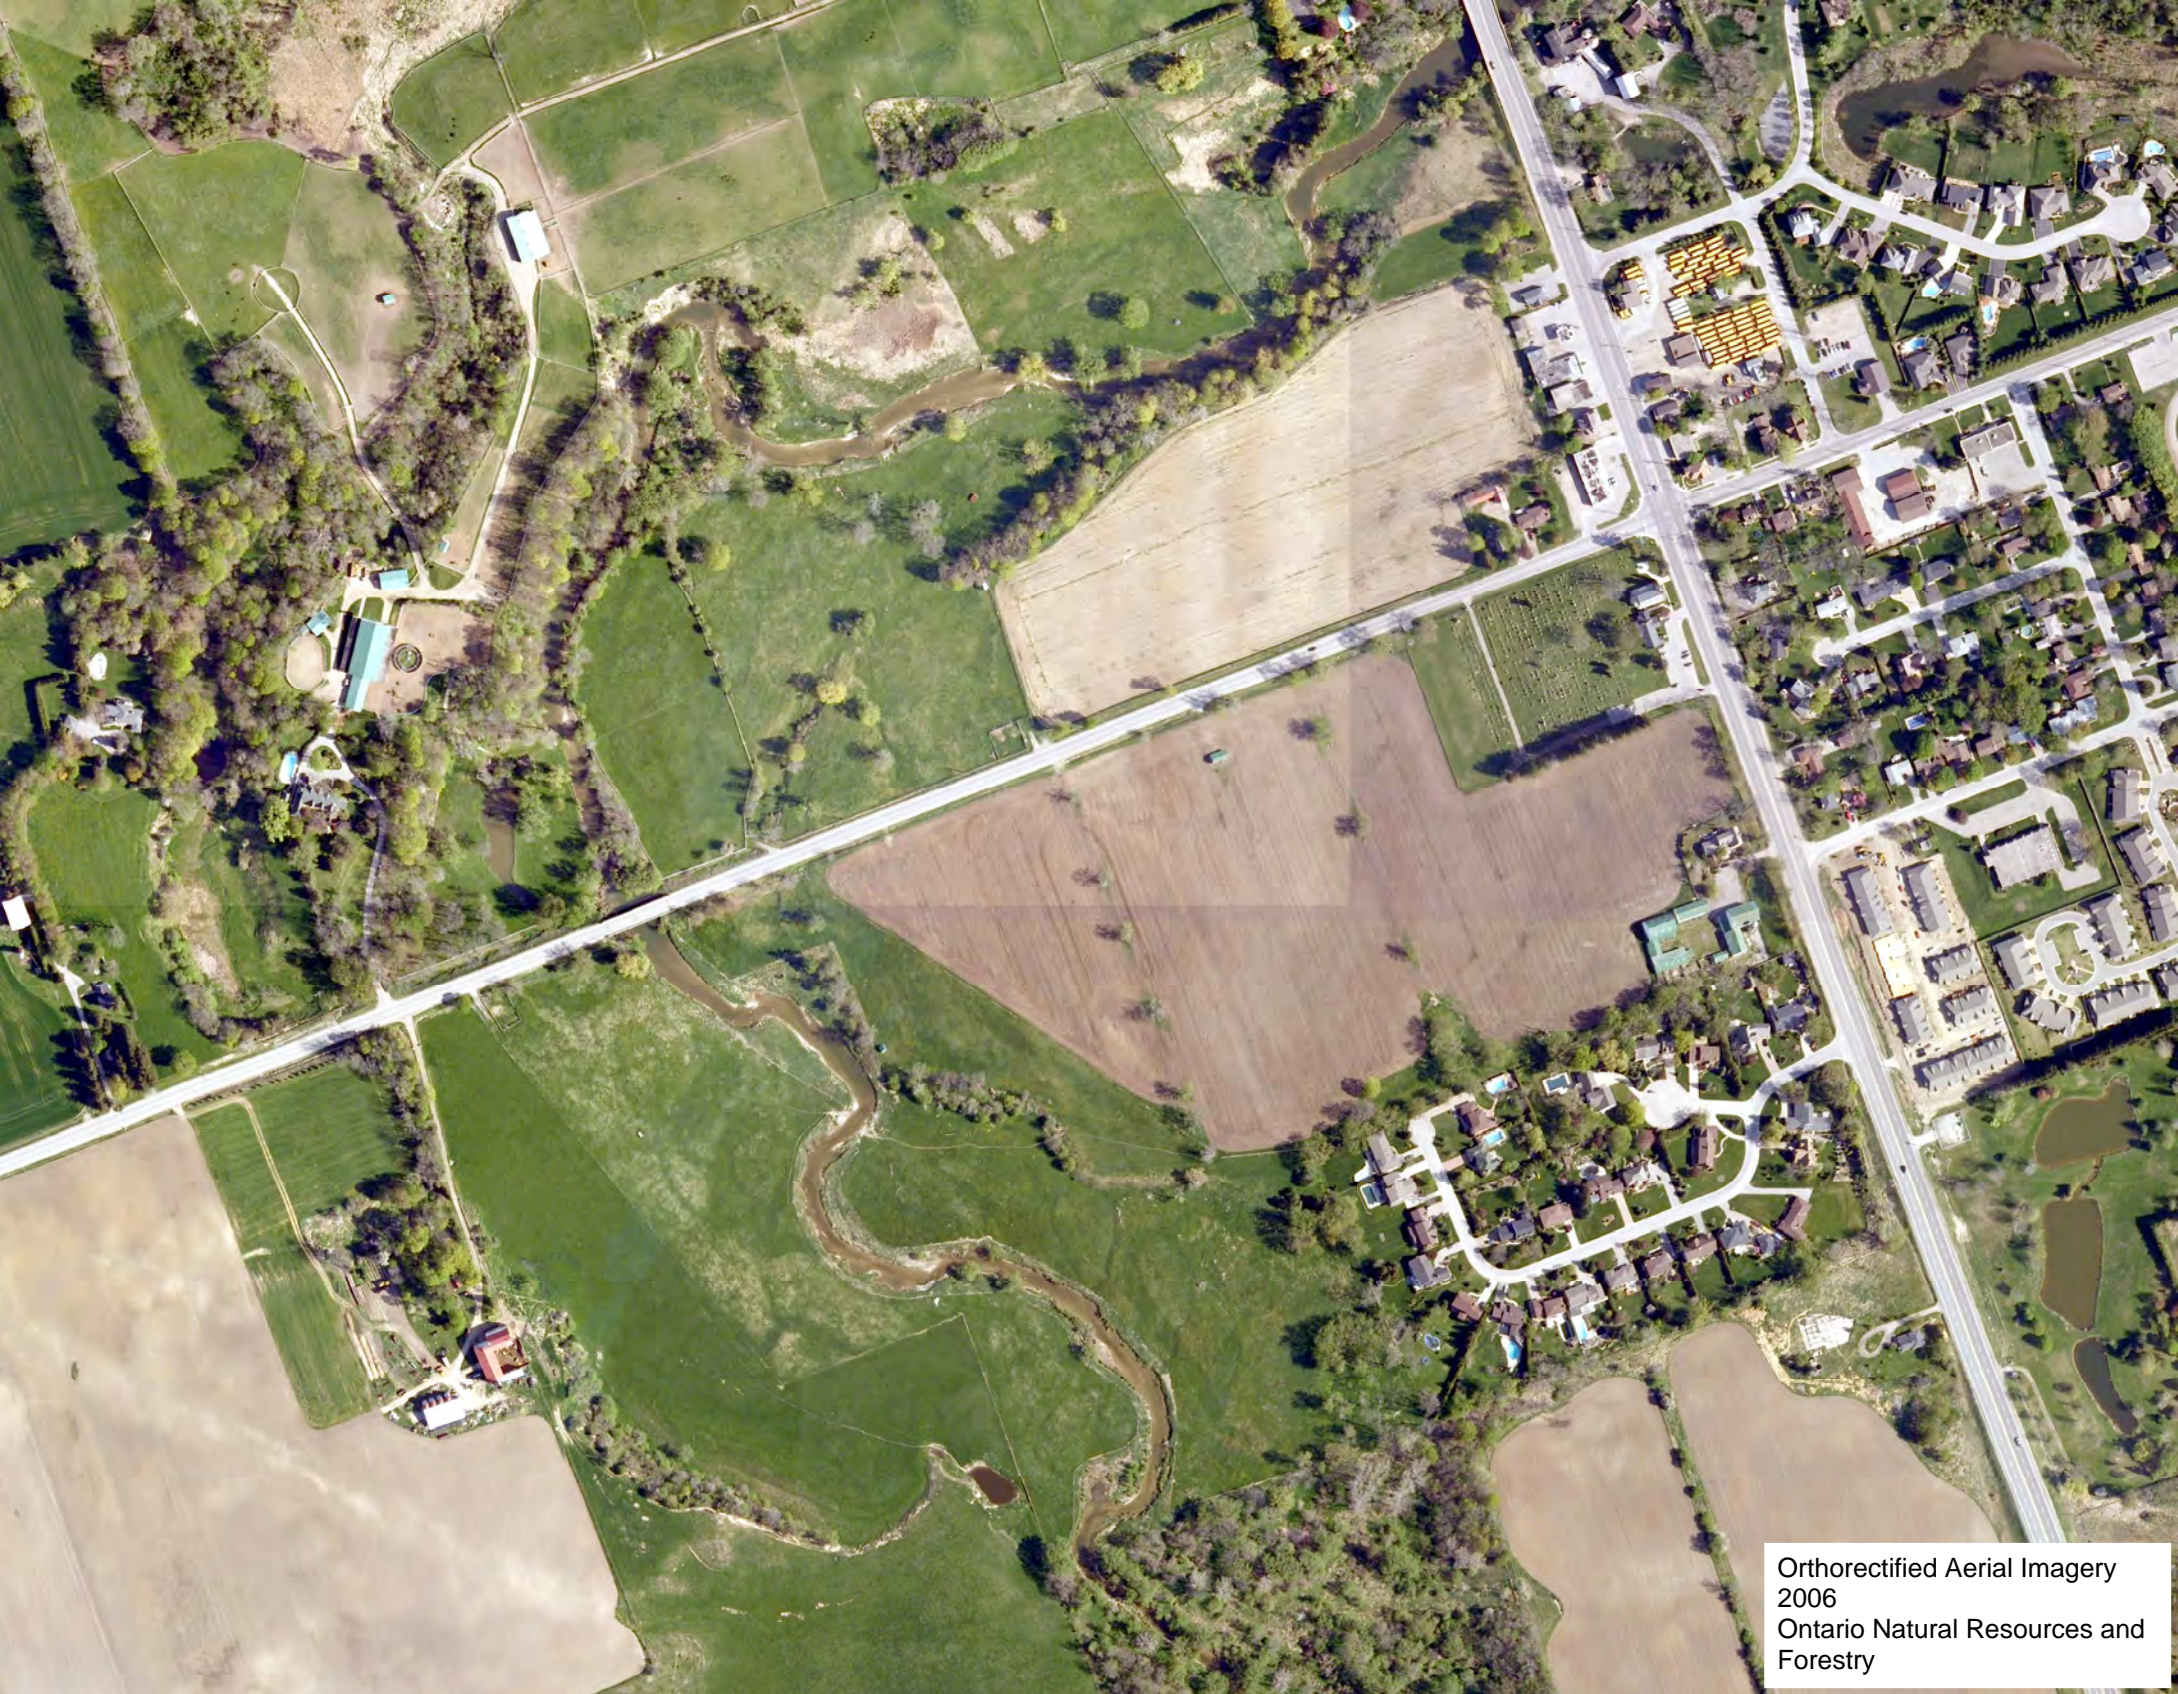
Orthorectified Aerial Imagery
2010
Ontario Natural Resources and
Forestry

Historical orthorectified aerial images (1980, 2006, 2010, 2020) were reviewed to gain insight into channel form and to identify any changes within the Study Area during the period of record. The imagery is presented in Appendix B. Key observations of the historical aerial images are summarized as follows:

To evaluate historic river planform movement, channel mapping was conducted based on a series of historical orthorectified aerial images (1980, 2006, 2010, and 2020). Channel mapping was conducted by digitizing the centerline of the watercourse in ArcGIS. The centerline was digitized using visual assessment and geomorphological judgement.
